QUINQUENNIAL INSPECTION REPORT 2022

TILEHOUSE STREET BAPTIST CHURCH, HITCHIN, SG5 2EE

DATE OF SURVEY: 11th of August 2022
NAME OF SURVEYOR: Adam Grant

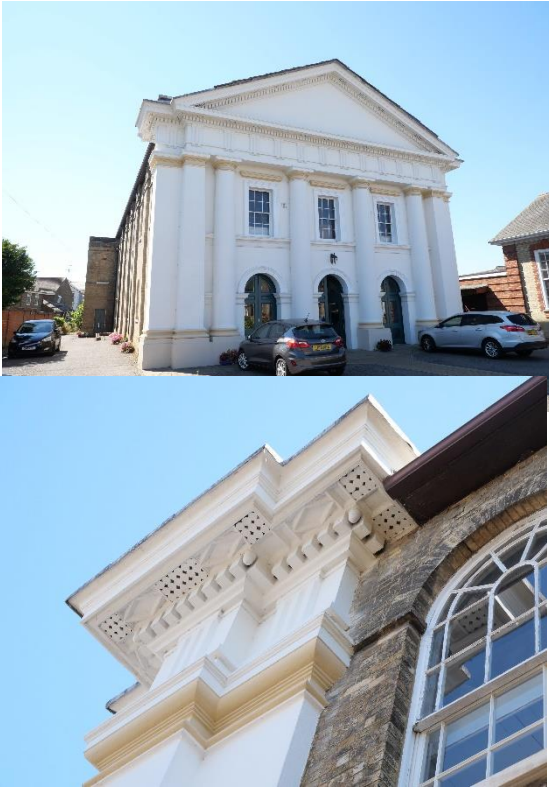
</div> <p>Inspection from ground level appear sound, without water staining at high level.</p> <p>Advise a drone survey is carried out to inspect the roof to prevent issues building.</p>	RM	E	1

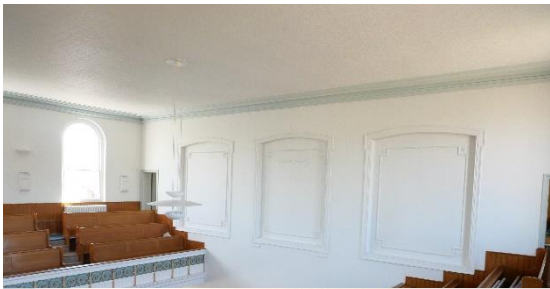
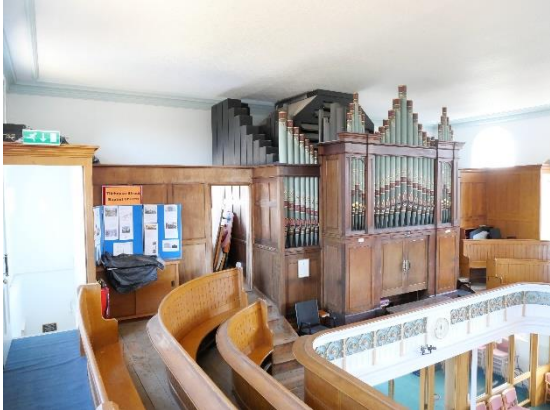
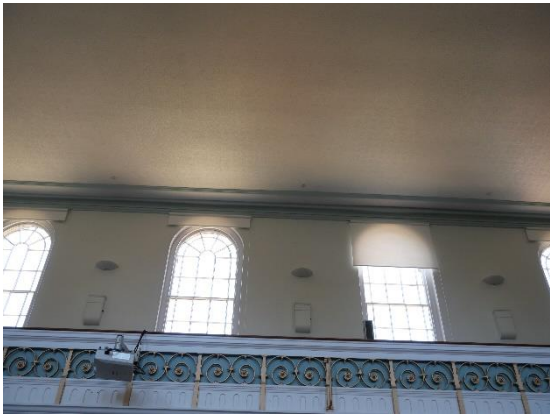
ii)	<p data-bbox="196 197 470 226">WORSHIP AREA CEILINGS</p> <div data-bbox="196 259 748 546">

</div> <p data-bbox="767 264 1302 327">All ceilings were in good condition, with no evidence of water ingress or deteriorated plaster.</p>	RM	E	1
-----	---	----	---	---

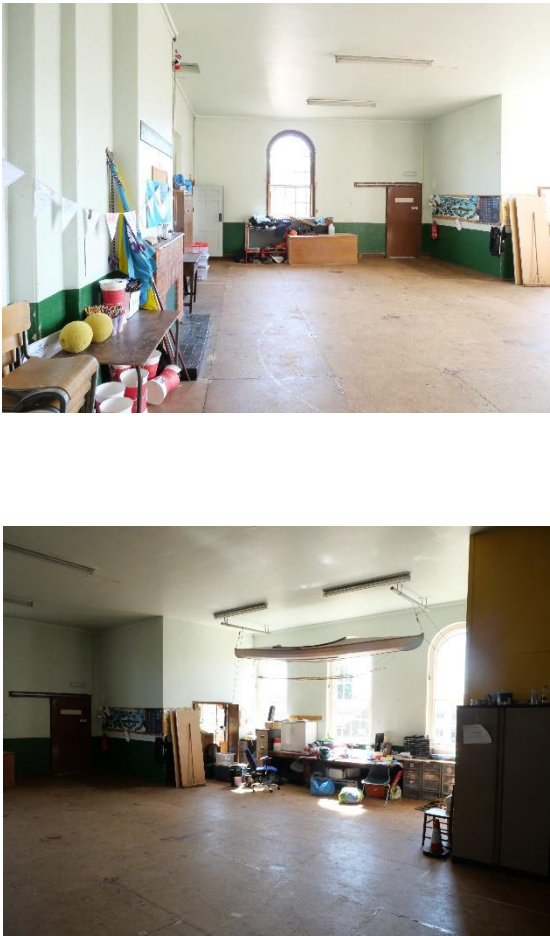
iii)	SCOUT HALL CEILINGS

<p>All ceilings were in good condition, with no evidence of water ingress or deteriorated plaster. Would benefit from redecoration.</p>	RM	E	1
------	---------------------	--	----	---	---

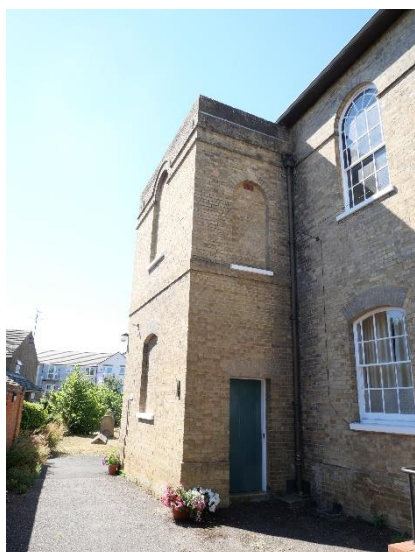
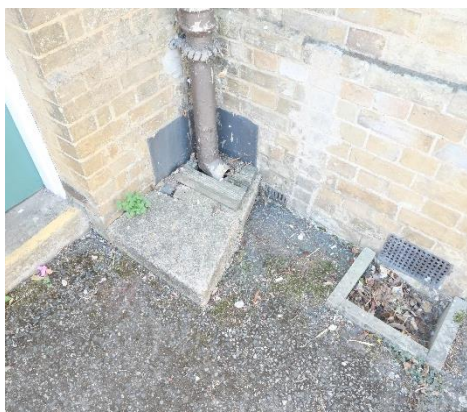
</div> <p>Suggest all gutter joints and ends are checked for leaks and gutters cleared of debris. This gulley is located at the rear door on the east Elevation from the stair tower, and will require regular cleaning. The detail could be improved, as overflowing water could enter the void below the floor via the partiallay covered air vent.</p> <p>Generally, the condition of the gutters and downpipes appear good, with no evidence of water dripping from joints.</p> <p>Advise a drone survey is carried out to inspect the rainwater goods to prevent issues building.</p>	RM	B	1

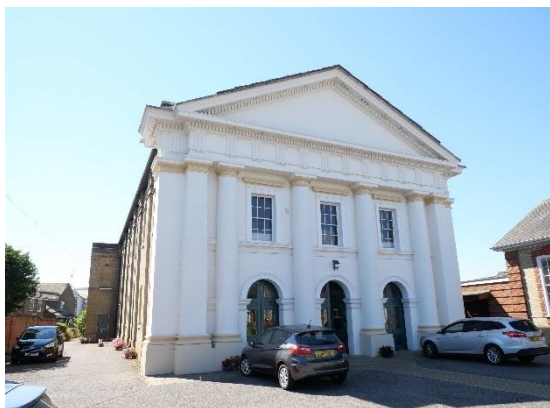
i)	<div><p>FRONT NORTH ELEVATION</p>

</div> <p>Having been recently redecorated, the overall condition of the front elevation is good.</p> <p>Note - suggest altering the tarmac so there is a drainage gap/gravel abutment to the masonry to reduce rainwater splashback.</p> <p>A specification / detail can be supplied if requested.</p>	RM	E	1

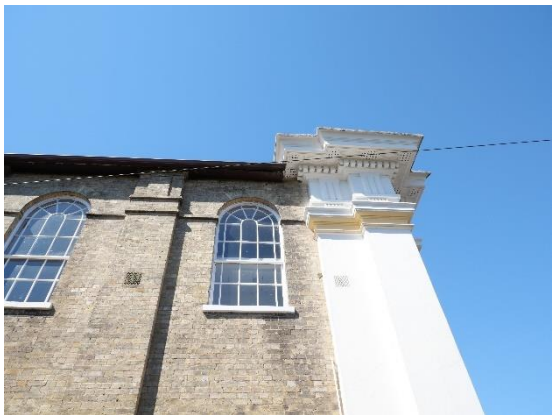
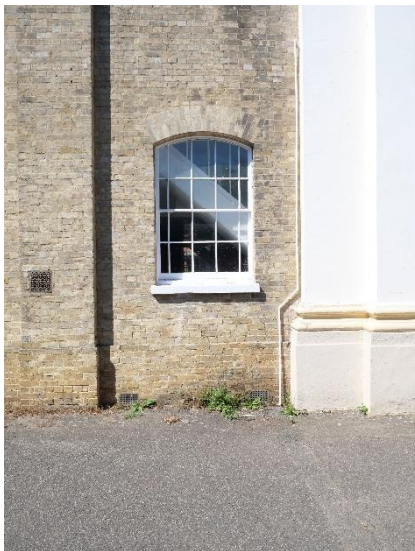
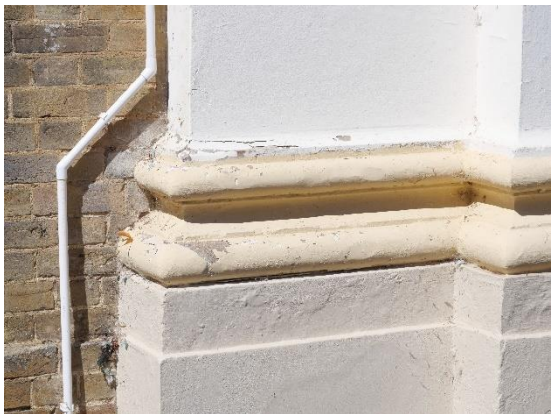
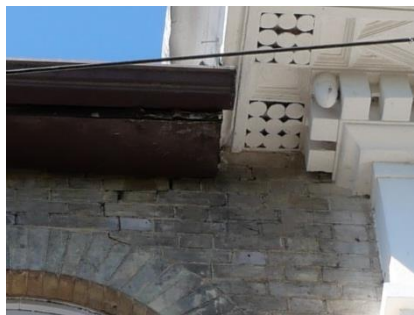
ii)	<p data-bbox="191 197 311 224">EAST WALL</p> <div data-bbox="199 241 753 654">

</div> <p data-bbox="191 1137 1236 1209">There appears to be (historic) dark water to the brickwork from the end of the gutter abutment to the mouldings, this will need to be checked to see if it is indded, historic, or a current issue.</p> <p data-bbox="191 1243 1268 1348">At the base of the wall, the tarmac abuts the brickwork at there is evidence of saturated brickwork in this area and plant growth. This maybe connected to this issue noted in 7.3 iii).</p> <p data-bbox="191 1382 1300 1487">As seen on the detail photograph, left, the lime mouldings have deterieriated and this section of wall needs repointing in air/hot lime mortar, suggest up to the stepped brickwork along the length of this wall. A specification / detail can be supplied if requested.</p> <p data-bbox="191 1520 1260 1626">Note - suggest altering the tarmac so there is a drainage gap/gravel abutment to the masonry to reduce rainwater splashback. A specification / detail can be supplied if requested.</p> <p data-bbox="191 1659 1161 1697">Advise a drone survey is carried out to inspect the rainwater goods to prevent issues building.</p>	SA	B	2

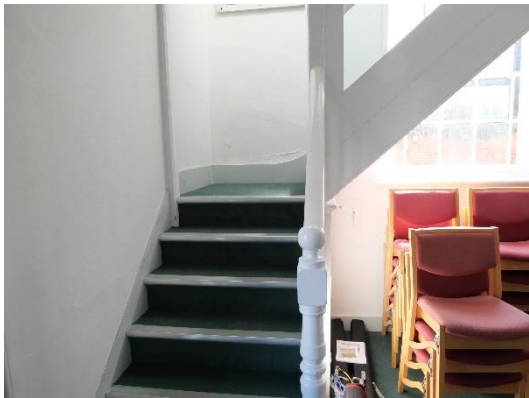
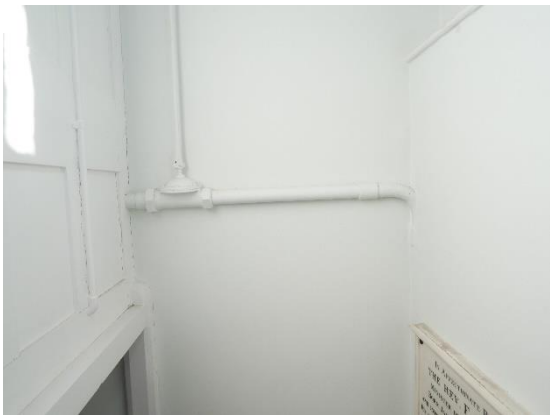
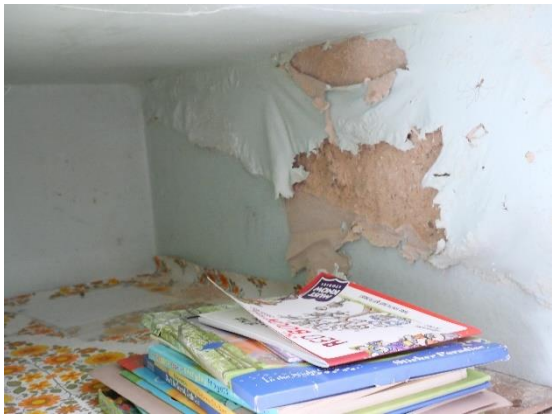
<div data-bbox="129 192 459 226">iii) EAST WALL INTERNALLY</div> <div data-bbox="188 268 719 663">

</div> <div data-bbox="762 719 1311 996"> <p>On the internal face of the east wall in 7.2 ii). It is evident that the wall has too much moisture. This may be coming from a historic water pipe built into the wall and/or the tarmac abutting the masonry externally.</p> <p>Suggest investigation into capping of redundant water pipe and alterations to the tarmac externally.</p> </div>	SA	B	2
--	--	----	---	---

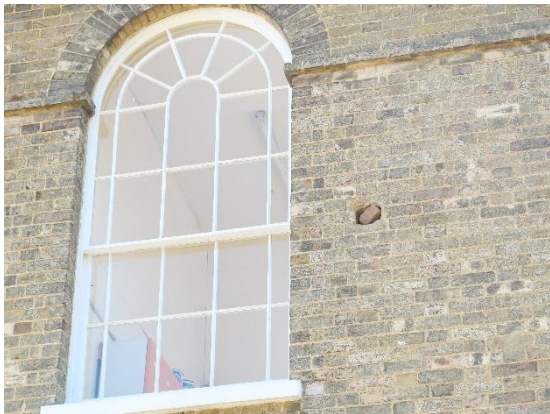
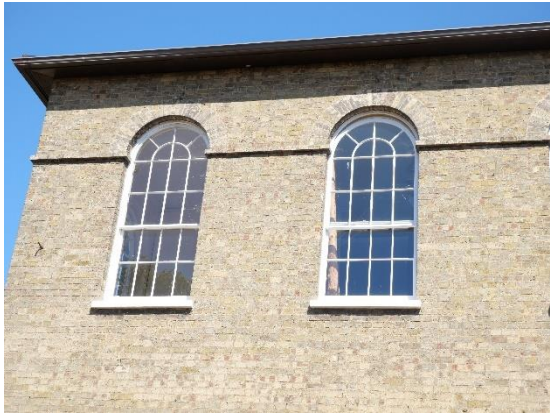
7.4	<i>Windows, Glazing and Ventilation</i>				
	i)	The external windows are in good condition, and decorative state.	RM	E	1

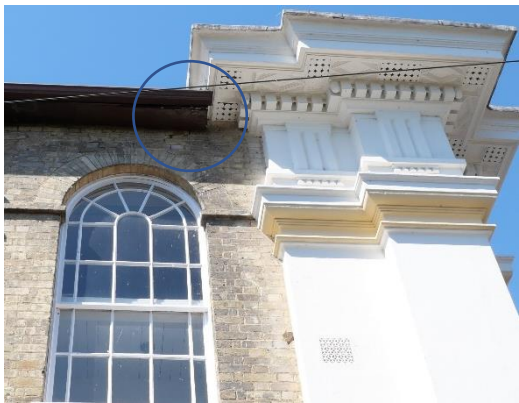
<p>The soffits will require redecoration within the next 5 years, as there are areas of paint peeling.</p>	RM	D	2
7.7	<i>Lightning Conductor (date of last test and result)</i>				
	i)	N/A			
7.8	<i>Bells, Bell frame & Clock</i>				
	i)	N/A

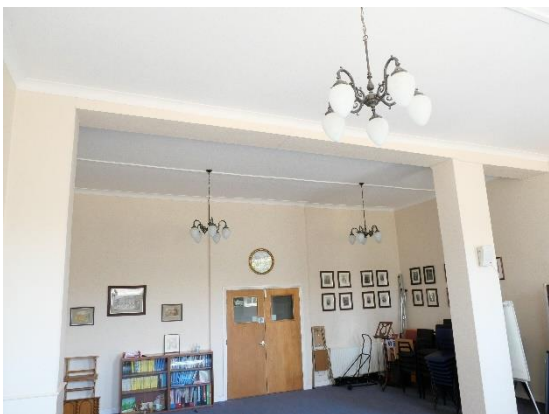
RM	D	3
The general decorative state of the internal walls is overall good and may require re-decoration in around 5 years' time.

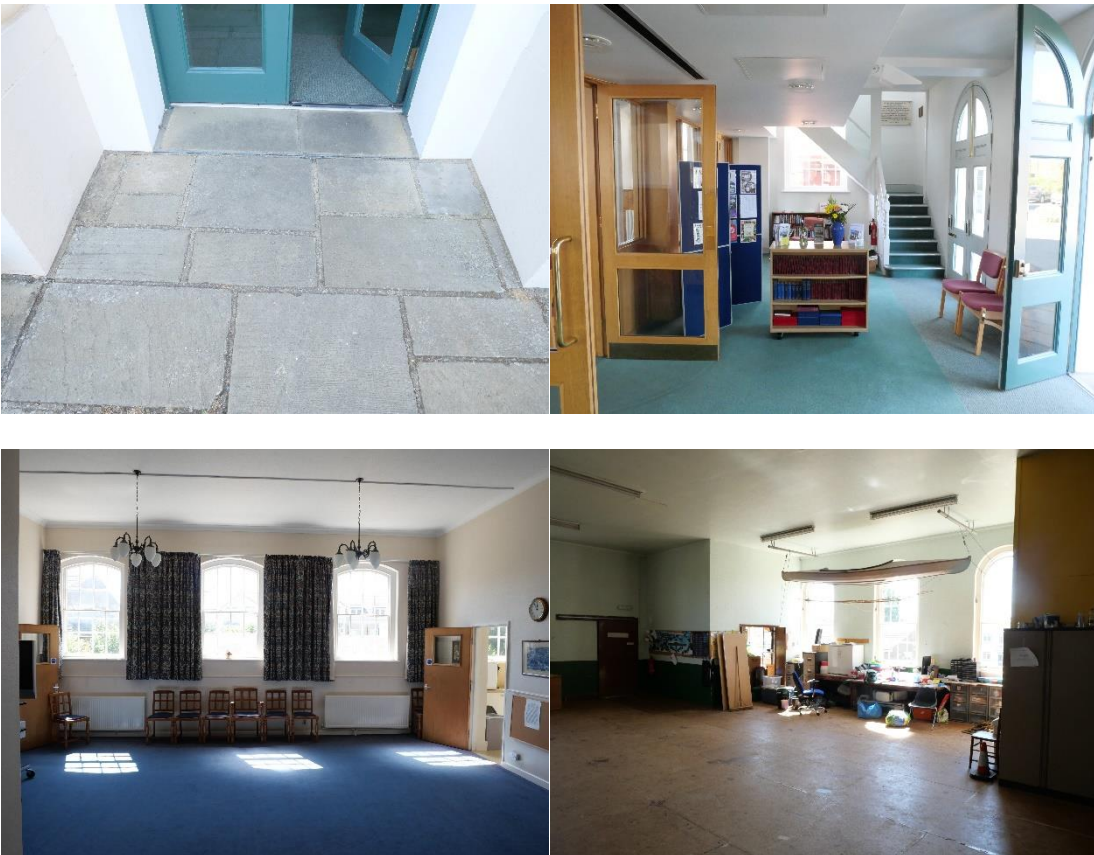
7.11	Floors and galleries	RM	B	2
	<p>i) The floor finishes to the church are overall good order, the scout hall flooring is in need of replacing and has raised edges to the boards which could become a trip hazard.</p>

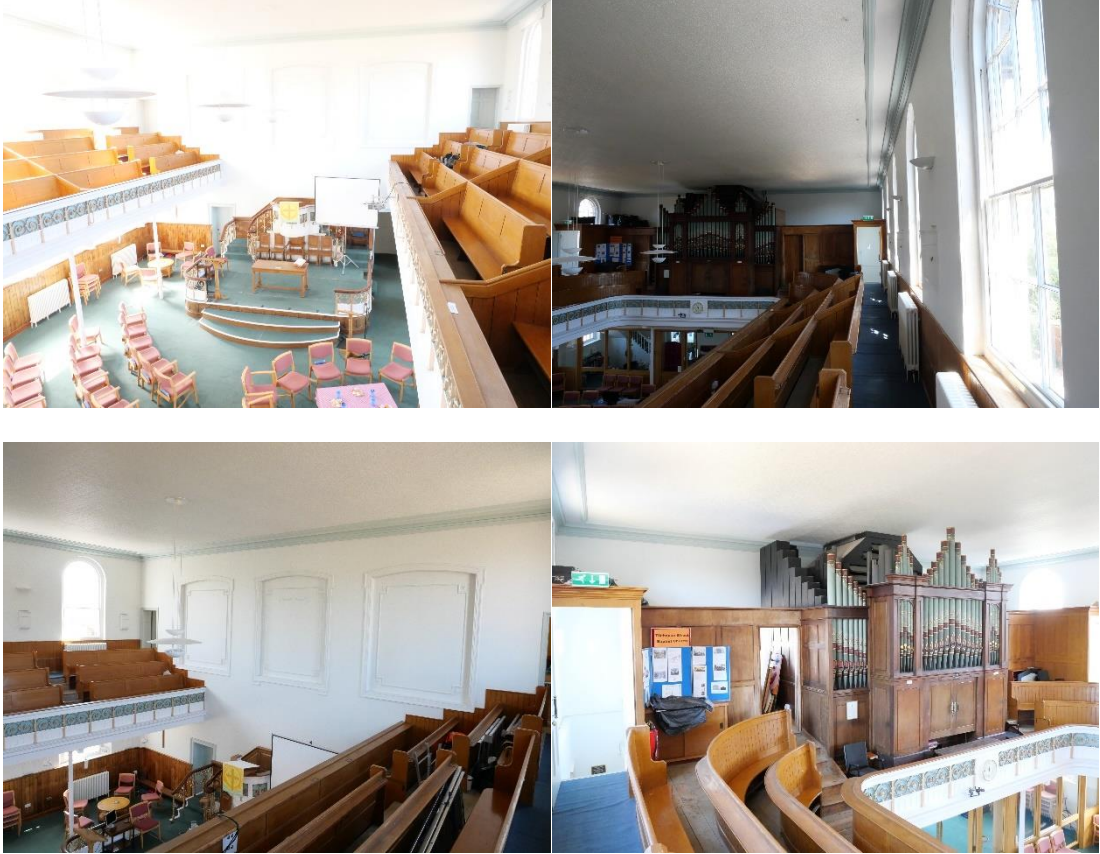
ii)	<p>GALLERY</p> <p>The galleries are in good decorative state, and appears to be mainly used for storage.</p> <p>Note that the balustrade is below the current building regulations standard height for fall protection.</p> <p>Suggest a separate Health and Safety report if the galleries are in regular use, or investigate restricting numbers, especially children.</p>

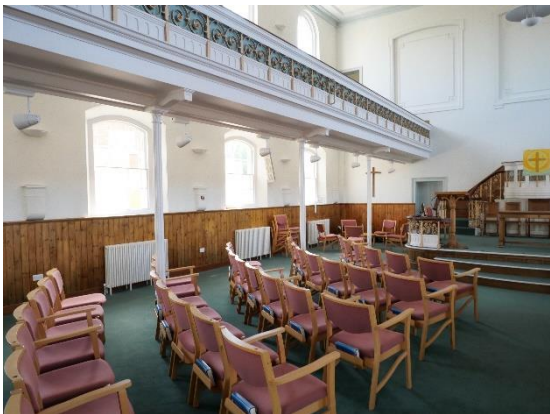
7.12	Furniture and fittings, including pews and other seating				
		MOVABLE CHAIRS The chairs to the main worship area are in good condition, being purchased in the 2010 reordering.

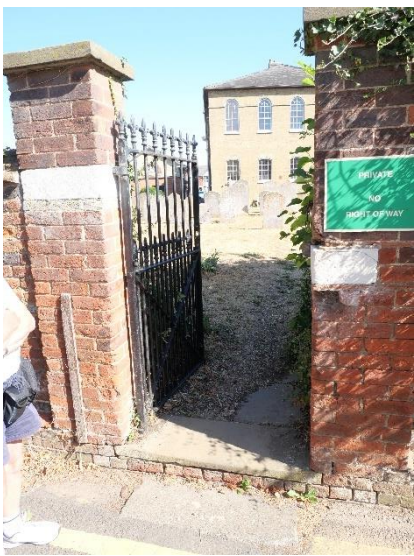
ii)	<p>SOUTH REAR GATE</p>

<p>Gate requires some adjustment to prevent catching on the stone threshold, where the hinges have worn. Suggest overhall and redecorate.</p>	RM	A	1
iii)	<p>WEST BOUNDARY WALL</p> <p>The rear boundary walls requires attention in creatin areas. In particulr the copings need to be repalced and top section of brickwork repointed in air/hot lime mortar to the side footpath.</p>  	RM	C	2

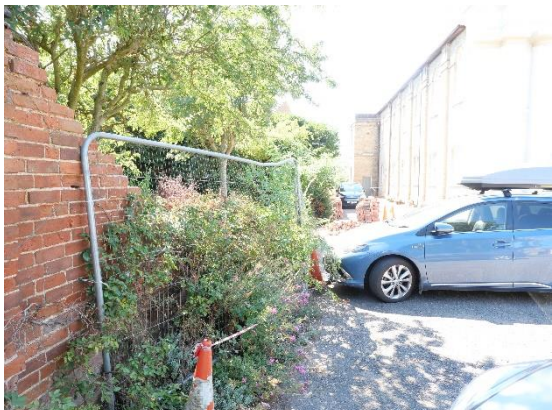
v)	EAST BOUNDARY WALL

<p>On the date of my survey, an area of wall has been fenced off after collapsing in the recent storms.</p> <p>I understand this was to be rebuilt in summer 2022.</p>	-	-	-
