QUINQUENNIAL INSPECTION REPORT 2022

TILEHOUSE STREET BAPTIST CHURCH HALLS, HITCHIN, SG5 2EE

DATE OF SURVEY: 11th of August 2022
NAME OF SURVEYOR: Adam Grant

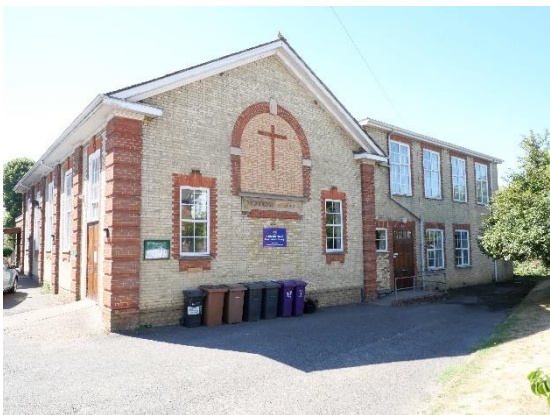
<p>Inspection from ground level appear sound, with verges pointed. Junction with flat roofed extension to be checked of debris and cleared.</p> <p>Advise a drone survey is carried out to inspect the roof to prevent issues building.</p>	RM	E	1

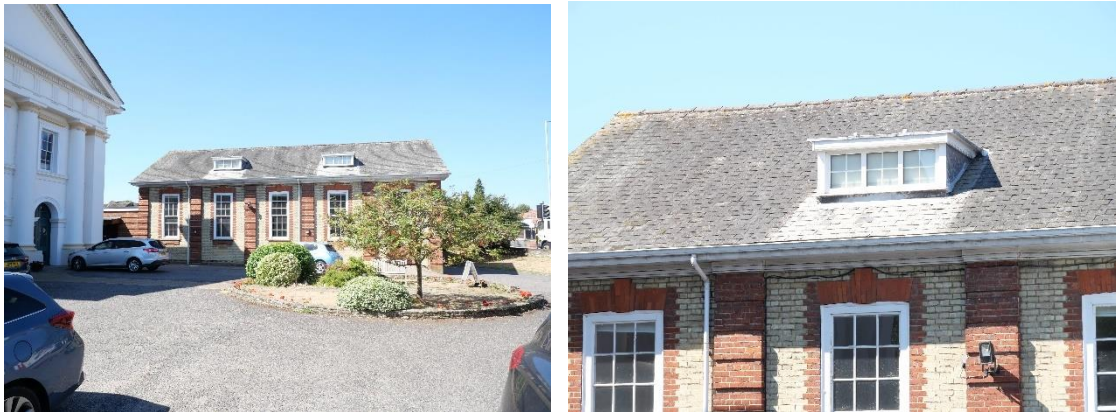
<p>EAST ELEVATION ROOF</p>

<p>Inspection from ground level appear sound.</p> <p>Advise a drone survey is carried out to inspect the roof to prevent issues building.</p>	RM	E	1
	ii)	<p>WEST ELEVATION ROOF</p>

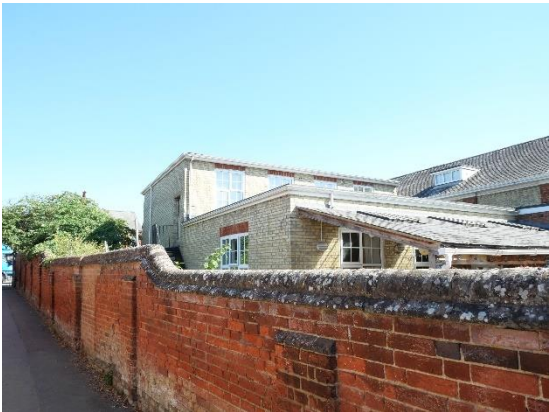
<p>Inspection from ground level appear sound.</p> <p>Advise a drone survey is carried out to inspect the roof to prevent issues building.</p>	RM	E	1

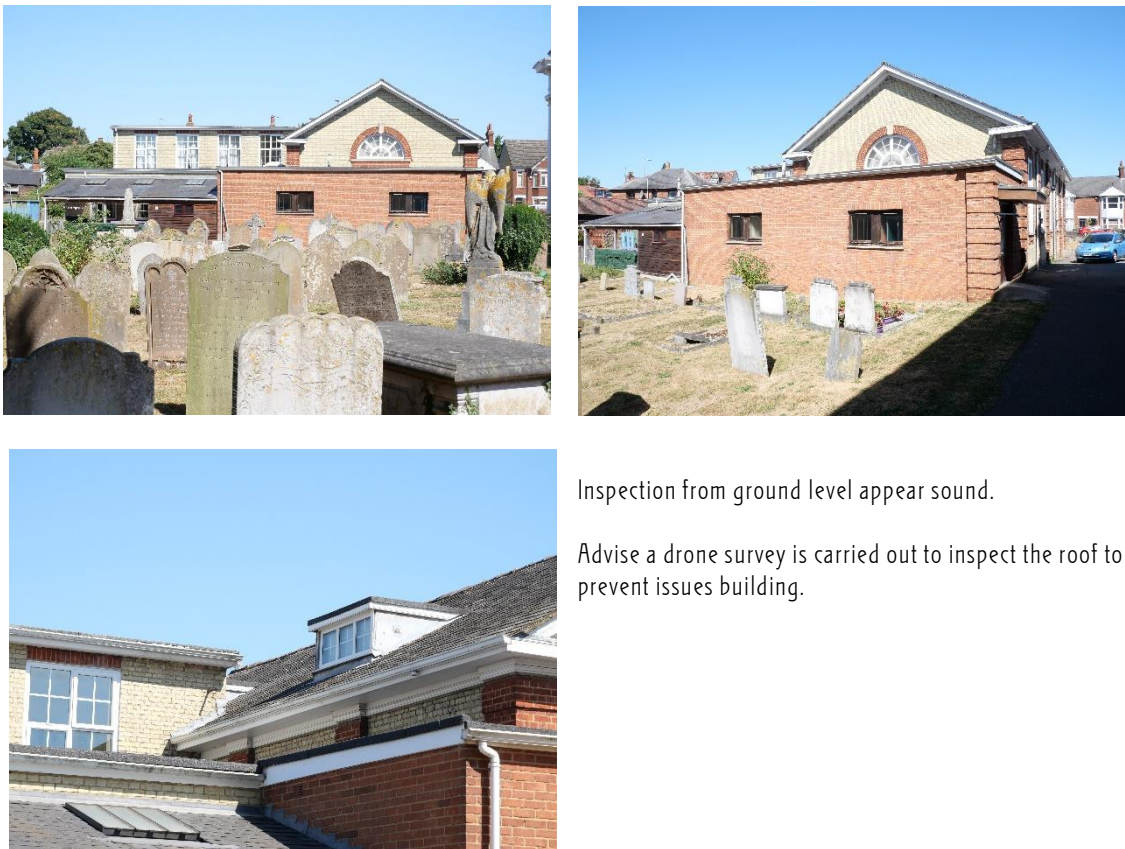
iii)	SOUTH ELEVATION ROOF

RM	E	1
		<p>Inspection from ground level appear sound.</p> <p>Advise a drone survey is carried out to inspect the roof to prevent issues building.</p>

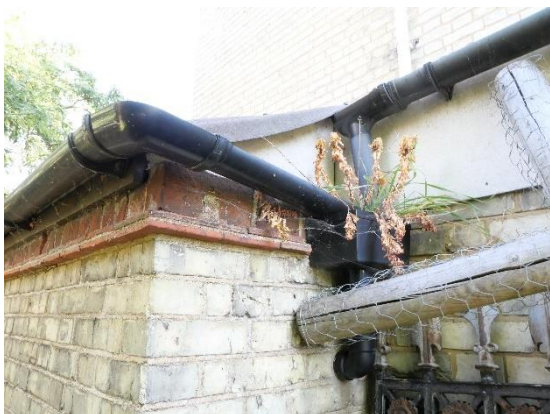
<p>Suggest all gutter joints and ends are checked for leaks and gutters cleared of debris. This hopper is located on the West Elevation and needs to be cleared.</p> <p>Advise a drone survey is carried out to inspect the rainwater goods to prevent issues building.</p>	RM	B	1

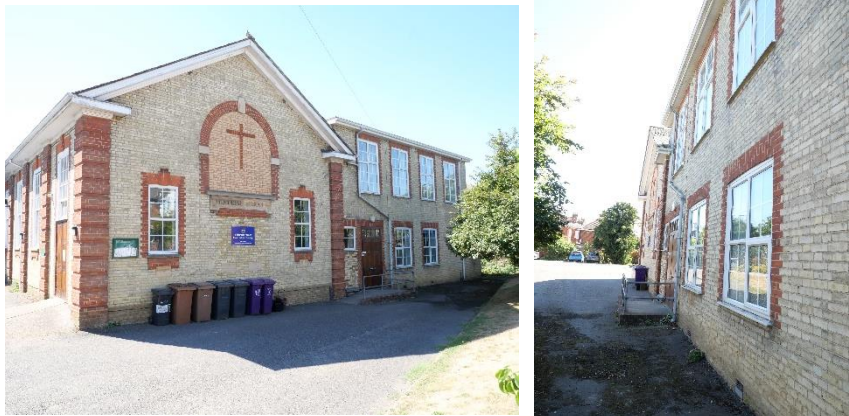
i)	FRONT NORTH ELEVATION			RM	E	1

<p>The overall condition of the front elevation is good.</p> <p>Note - suggest altering the tarmac so there is a drainage gap/gravel abutment to the masonry to reduce rainwater splashback. A specification / detail can be supplied if requested.</p>					
ii)	EAST WALL			SA	A	1

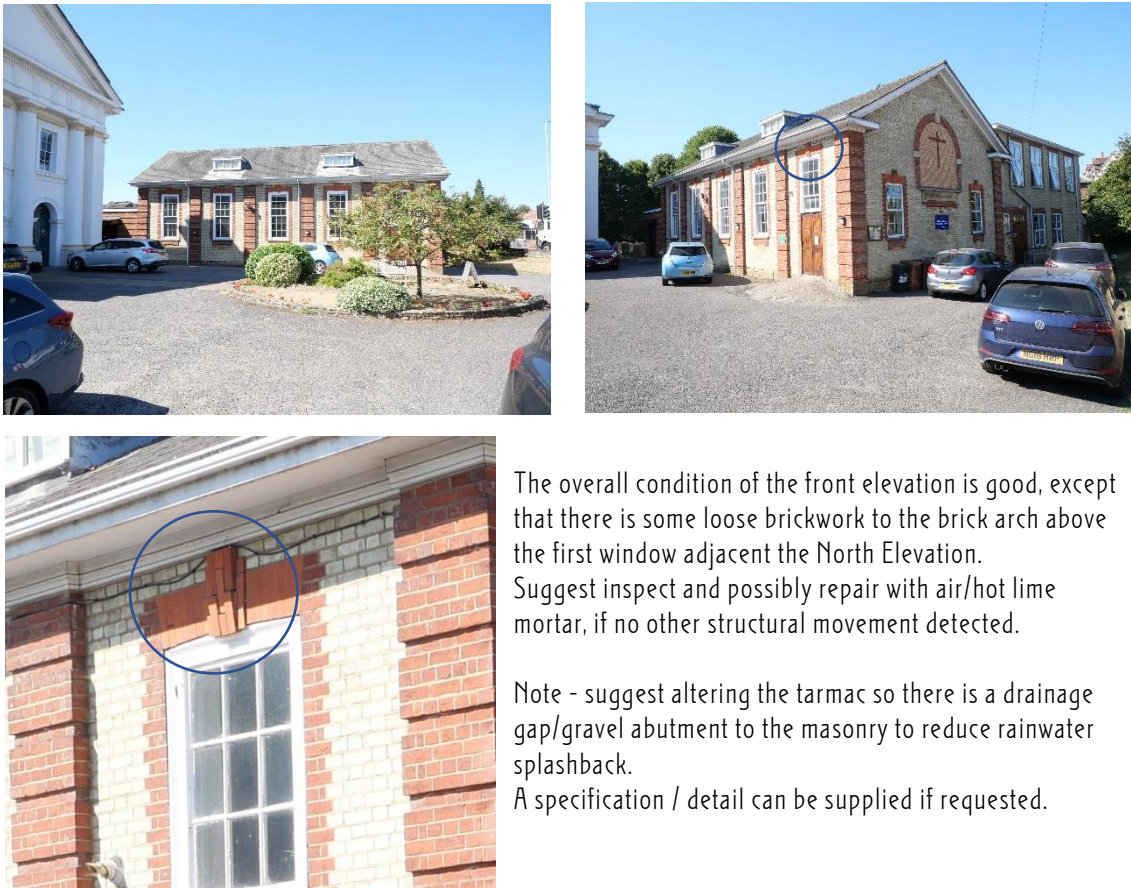
<p>The overall condition of the front elevation is good, except that there is some loose brickwork to the brick arch above the first window adjacent the North Elevation. Suggest inspect and possibly repair with air/hot lime mortar, if no other structural movement detected.</p> <p>Note - suggest altering the tarmac so there is a drainage gap/gravel abutment to the masonry to reduce rainwater splashback. A specification / detail can be supplied if requested.</p>

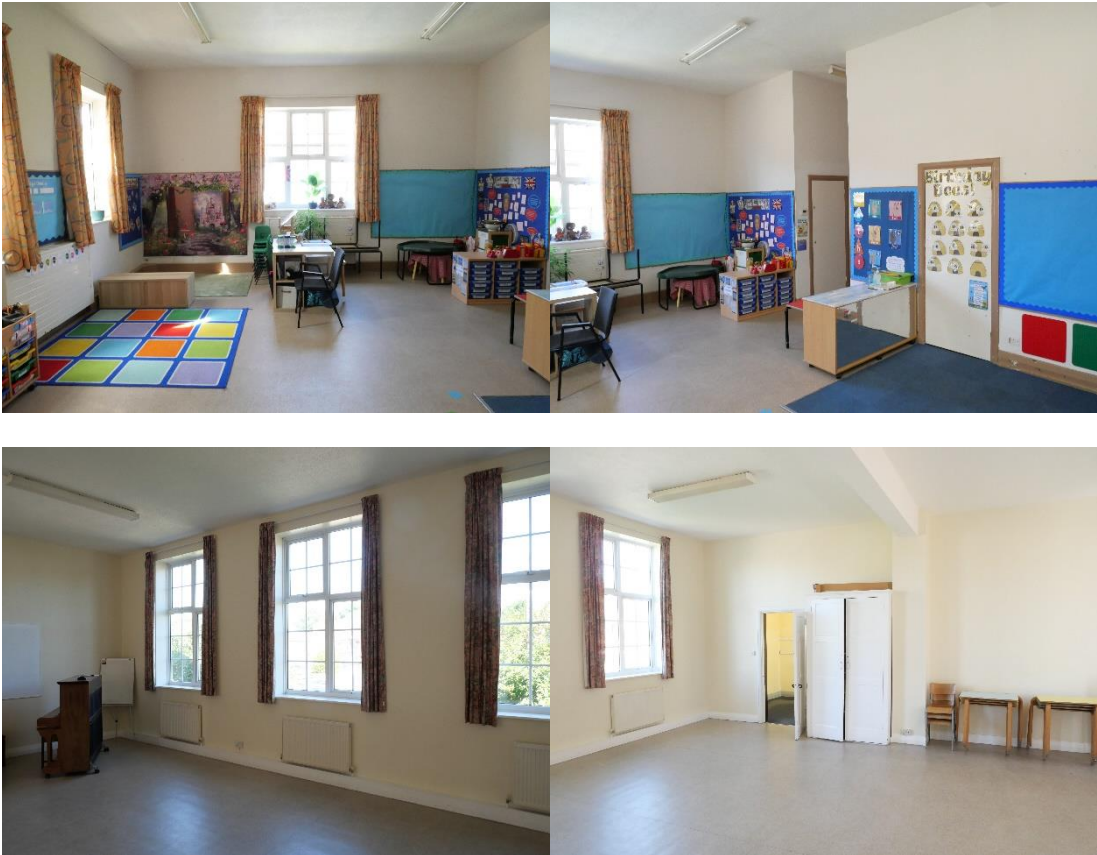
ii)	<p>The general decorative state of the internal walls is overall good and may require re-decoration in around 5 years' time.</p>

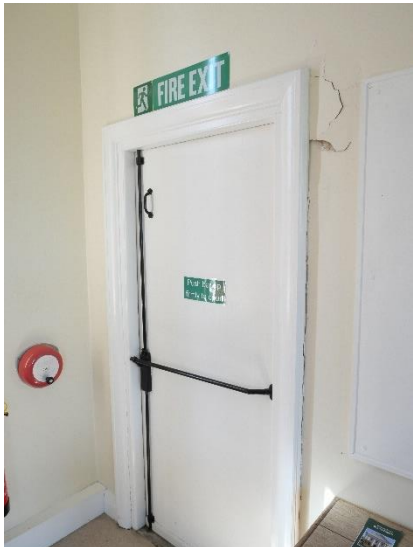
iii)	<p>The escape door and frame within the first floor meeting room, requires removal and refitting and potentially rebuild the masonry around the door.</p>

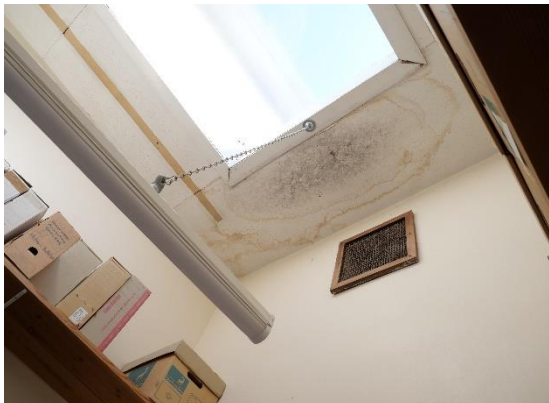
RM	A	1
iv)	<p>There appears to be a (potentially historic) leak around the rooflight within the groundfloor store room to the nursery. Suggest investigate flashings and upstands around rooflight.</p>

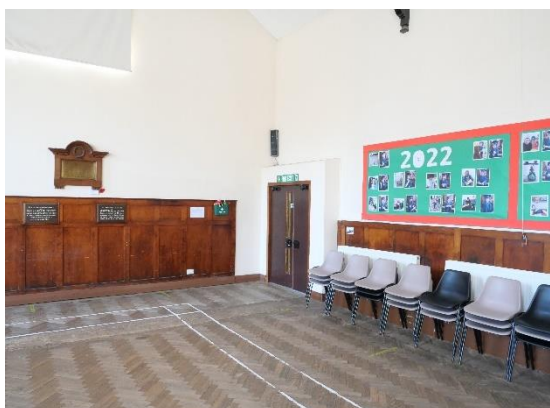
7.11	Floors and galleries					
	i)	<p>The floor in the hall is in serviceable condition, but would benefit from being sanded and refinished.</p>

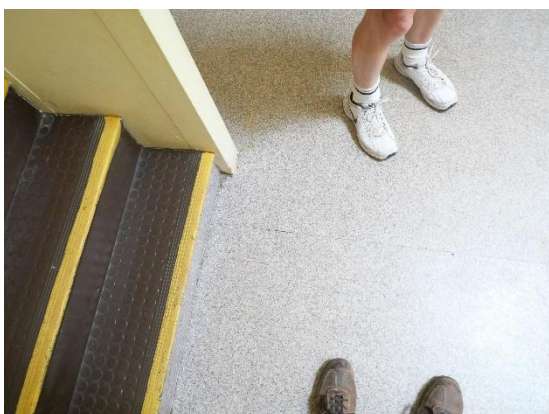
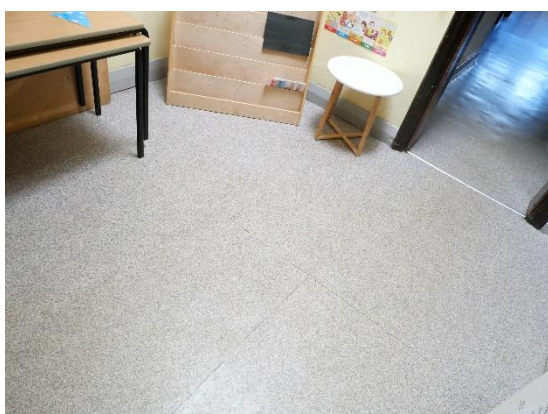
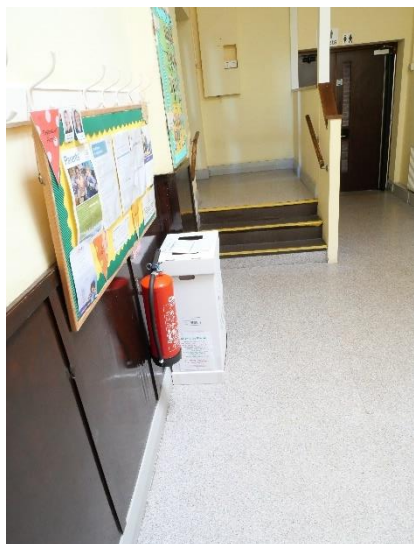
<p>The edges of the vinyl flooring are beginning to be raised, suggest vinyl flooring specialist re-joins the edges of the vinyl.</p>	I	A	1

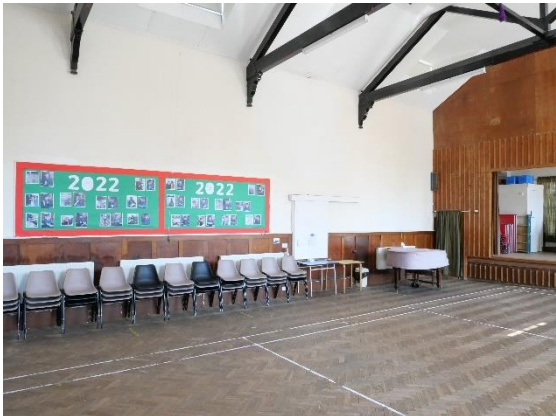
7.12	Furniture and fittings, including pews and other seating				
	MOVABLE CHAIRS		-	-	-
	The chairs to the main hall appear in serviceable condition.

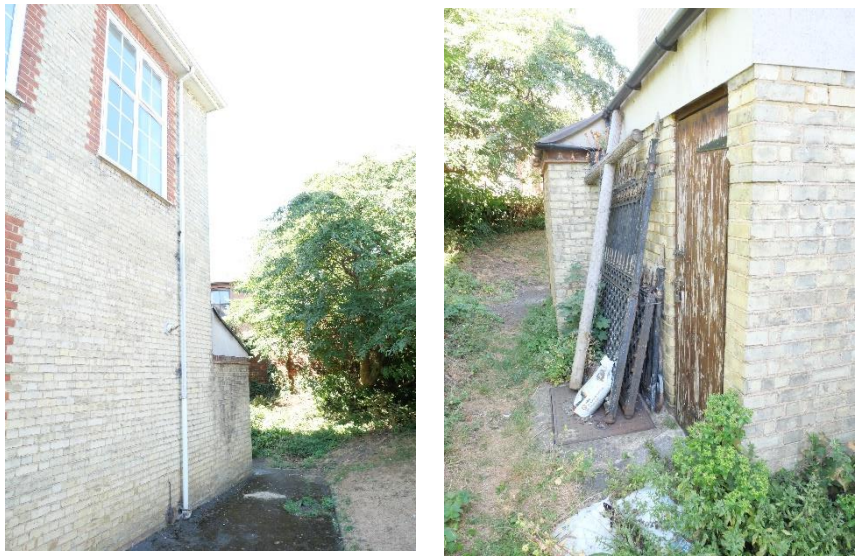
7.19	<i>Churchyard, including boundary walls, fences, gates, paths, trees and any monuments or memorials that are of special merit.</i>					
	i)	FIRE ESCAPE ROUTE FROM THE FIRST FLOOR EXTERNAL STAIR			RM	A 1

<p>The path should be kept clear of vegetation and debris</p>
